CASE REPORT

Case Report: Traumatic Incomplete Fracture of an Implanon NXT[®] Contraceptive Implant

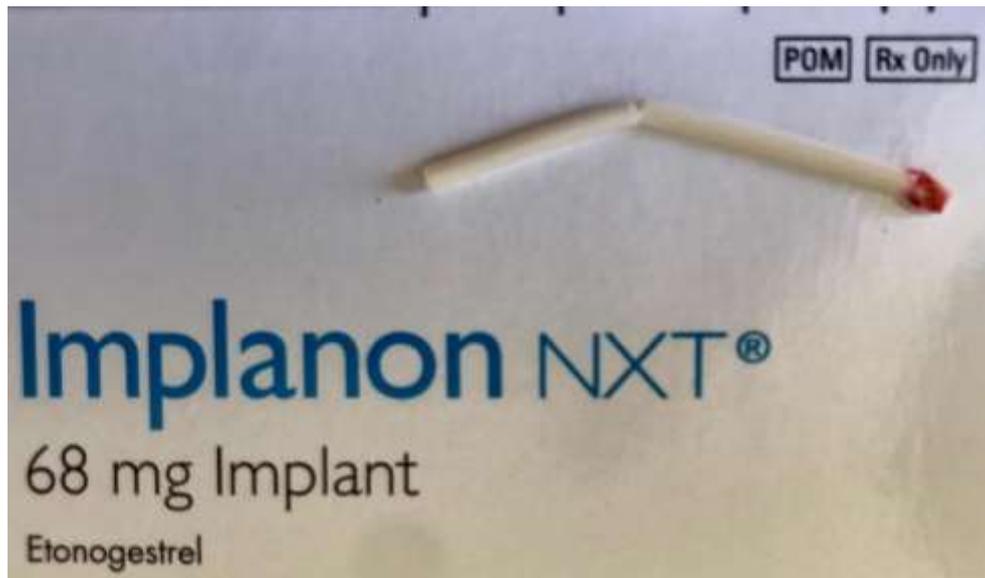
Figure 1: Photograph of the incompletely fractured Implanon NXT® implant presented in this case study, after removal

A 26-year-old woman, gravida 1, para 1, presented to our sexual and reproductive health clinic in Botswana in November 2017 requesting removal of her ENG implant, Implanon NXT[®], due to concern that it had “broken in half”. The woman reported that four days prior to presentation, her seven-year-old daughter had stamped on her left, inner, upper arm, over the site of the implant. She had immediately noticed a palpable bend in the implant and then unexpected and heavier than usual bleeding within a few days. The ENG implant had been inserted 13 months earlier, in accordance with the manufacturer’s instructions¹ at the same sexual and reproductive health clinic and without complications. She had been satisfied with it prior to this presentation. She had no past medical history, was HIV negative, on no concomitant medications, and had had a recent normal Pap smear. She reported regular menstrual cycles before initiating the implant and regular monthly bleeding after implant initiation. She had been able to palpate the implant since insertion. On clinical assessment, the implant was palpably bent in the middle section. It was removed via the routine “pop-up” technique, as described in the manufacturer’s prescribing information¹. Inspection confirmed it to be bent and incompletely fractured at the middle (Figure 1). A new ENG implant was inserted through the same removal incision. There were no complications associated with the removal or re-insertion procedures. The woman was advised to return for follow-up in one month and the manufacturer was notified.
